CIA IMAGERY ANALYSIS DIVISION

CIA/PIR-61089

ANALYSIS OF SOVIET TYPE III-D ICEM SITES

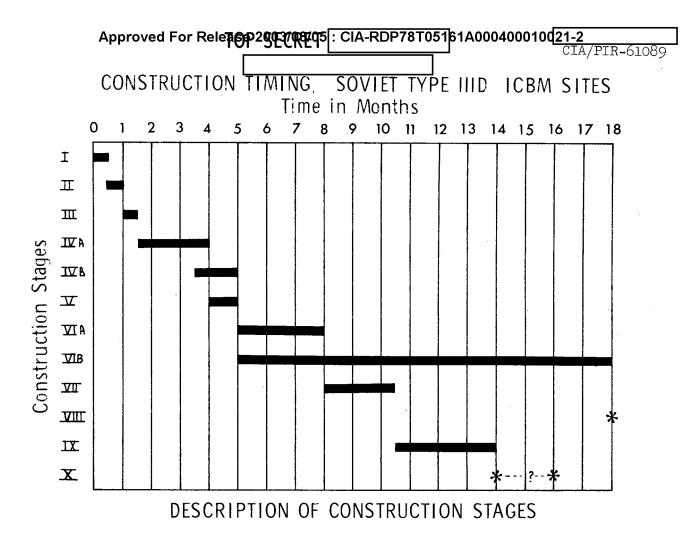
1	CLEARING AND GRADING
11	OPEN CUT EXCAVATION
	CORING VISIBLE
IVA	RAMPS / FORMS UNDER CONSTRUCTION FOR SILO
IVB	CLEARING AND EXCAVATION FOR GUIDANCE AND CONTROL
V	SILO COMPLETE TO SURFACE LEVEL
VIA	INSTALLATION OF RAIL-LIKE OBJECTS
	LEVEL ACCESS ROAD PATTERN NOT WELL DEFINED
VIB	CONTROL AND GUIDANCE UNDER CONSTRUCTION
VII	ROAD PATTERN WELL DEFINED. ENVIRONMENTAL
	COVER OFTEN VISIBLE OVER SILO
VIII	CONTROL AND GUIDANCE COMPLETED
IX	ROAD PATTERN COMPLETE. SURFACING OF ROAD AND
	INSTALLATION OF SILO DOOR
Χ	SITE COMPLETE

This study will present a photographic chronology of the development of the Type III-D sites; provide pertinent mensural data; and analyze construction timing (Figure 2). The construction stages used have been developed jointly by IAD and CIA/ORR Forces Division analysts and have been previously applied in a number of IAD reports relating to Soviet single silo deployment.

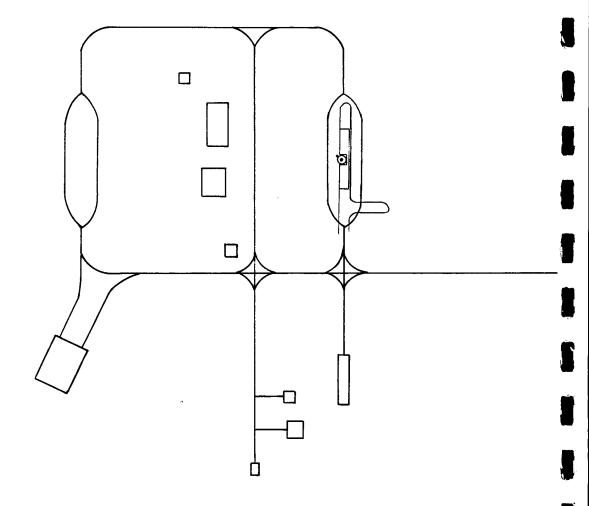
SKETCH (TO SCALE) ILLUSTRATING RELATIVE SIZES OF A TYPICAL TYPE II B AND TYPE III D ICBM LAUNCH SITE

With their inherent small size, about 10 to 15 acres compared to about 90 acres for the Type II soft sites (Figure 3) and because of the lack of identifiable ICEM launch site support facilities, the individual Type III-D sites have, especially early in their construction cycle, presented a problem in identification. A few sites have been visible on photography ten to twelve times over a period of twelve to sixteen months before identification.
